Structural Evaluation Report  
for Existing Buildings at  
Livingston Mountain Communications Site  
Camas, Washington

American Tower  
Corporation

April 21, 2014

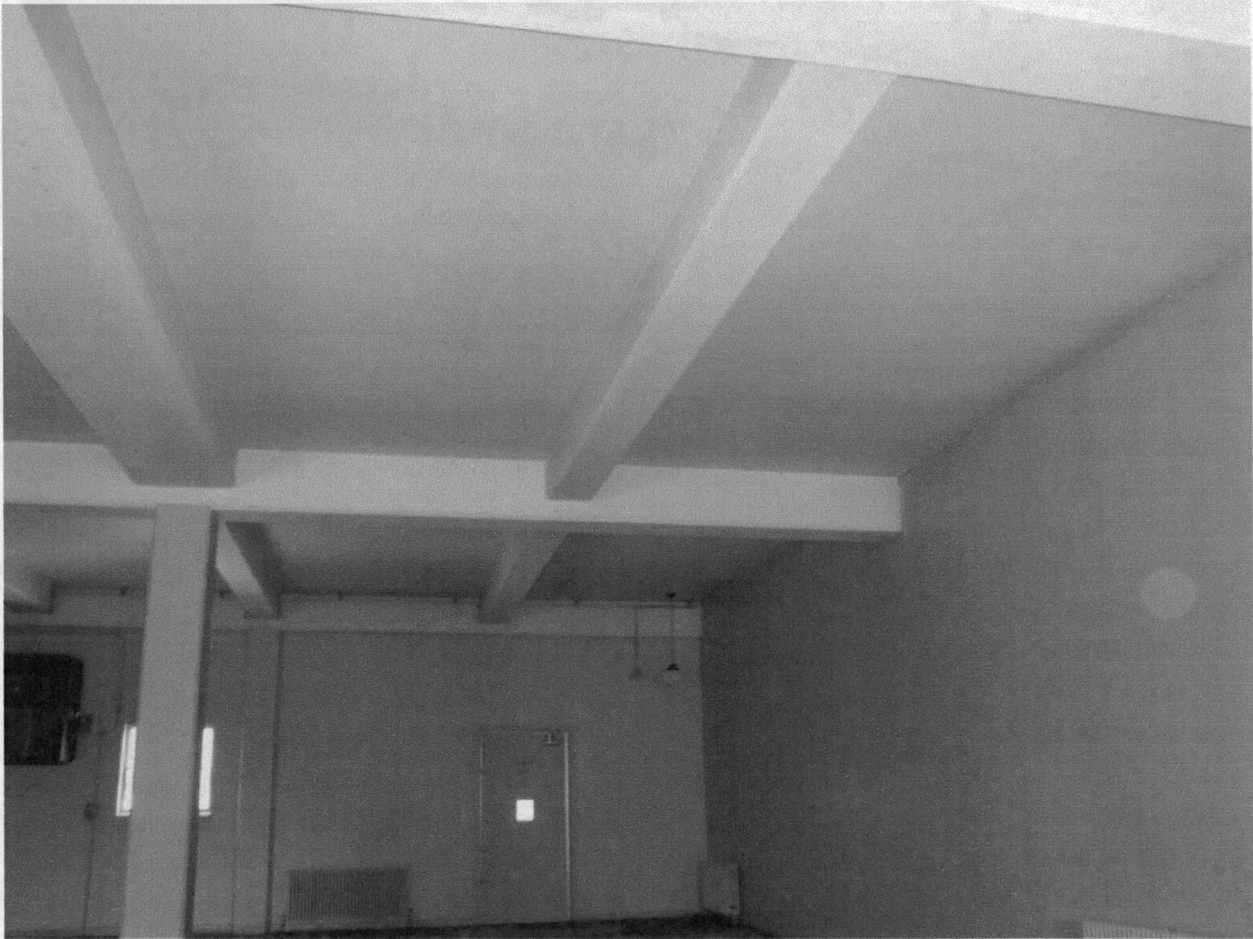
**Floor Slab and Beams** – We attempted to calculate capacities of the slab and beam system with minimum assumed reinforcing. With the minimum steel, the members failed to achieve even dead load capacity. Since there are no signs of gravity load distress, it became evident that either the concrete floor and roof system are heavily reinforced or they have steel beams encased within them. The second floor currently supports existing battery racks and old communications equipment in one area. We estimate the existing battery racks are imposing close to 170 psf on the floor system. There were no signs of overstress on the existing slab, sub purlins or beams in this area. The floor appeared to be level and did not show any signs of deflection or settlement. By the condition of the existing construction we do not anticipate the existing gravity load resisting system to have problems carrying the existing gravity loads applied to the structure.

1. Typical construction of floor and roof supports beams and columns

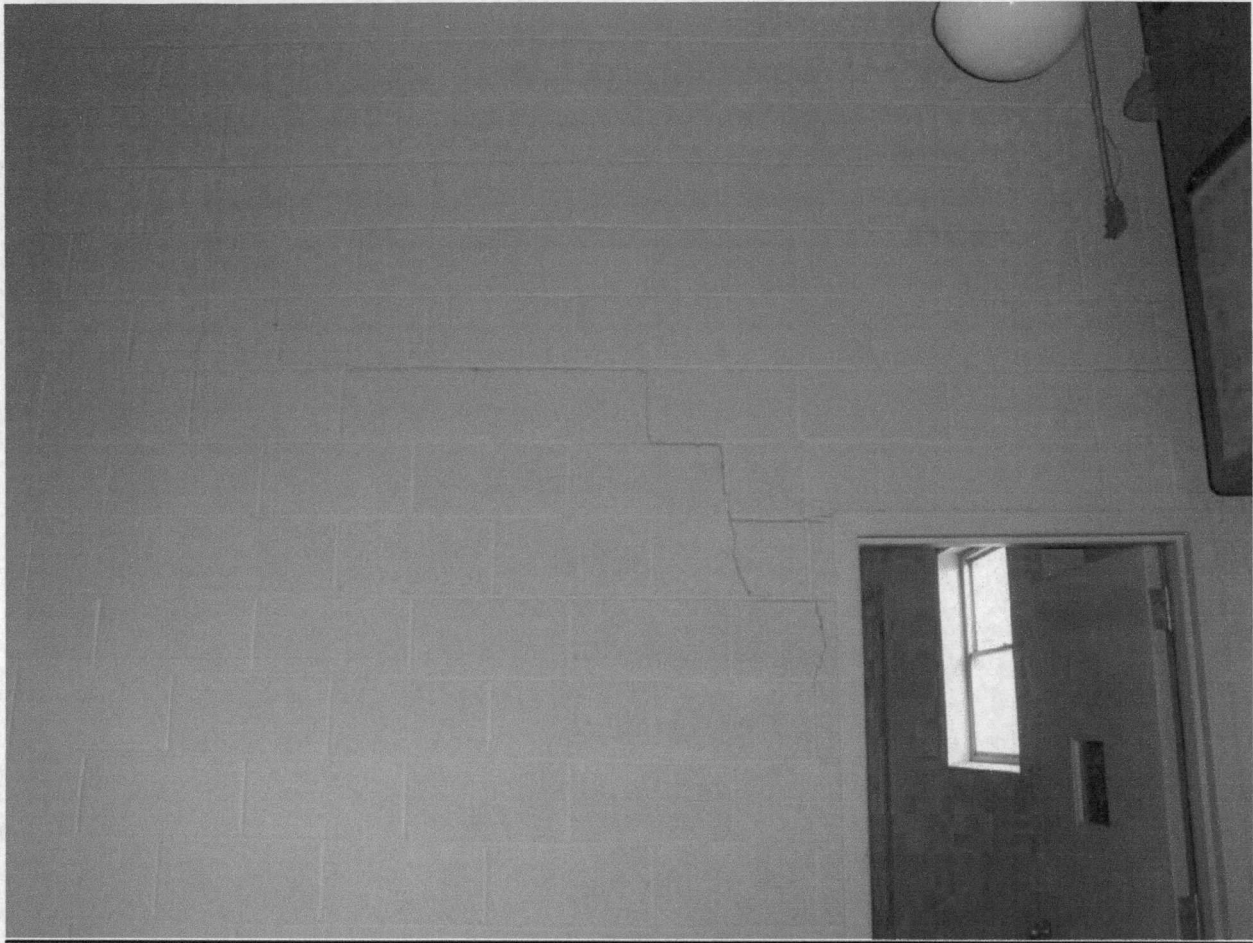
**Note:** Most of the partitions walls appeared to be 6" unreinforced cmu walls. These walls had cracks at various locations but occurred mostly above door openings.

A few non-compliant items were noted on the ASCE-31 check sheets. The non-compliant items were all for secondary components in the building. Most notably are the interior masonry partition walls that are likely unreinforced and unanchored to the concrete structure. This presents the highest hazard as these walls will likely collapse during a moderate or larger seismic event. Other non-compliant items found are common for older structures don't present high seismic hazards.

2. Interior CMU partition walls with cracks at openings

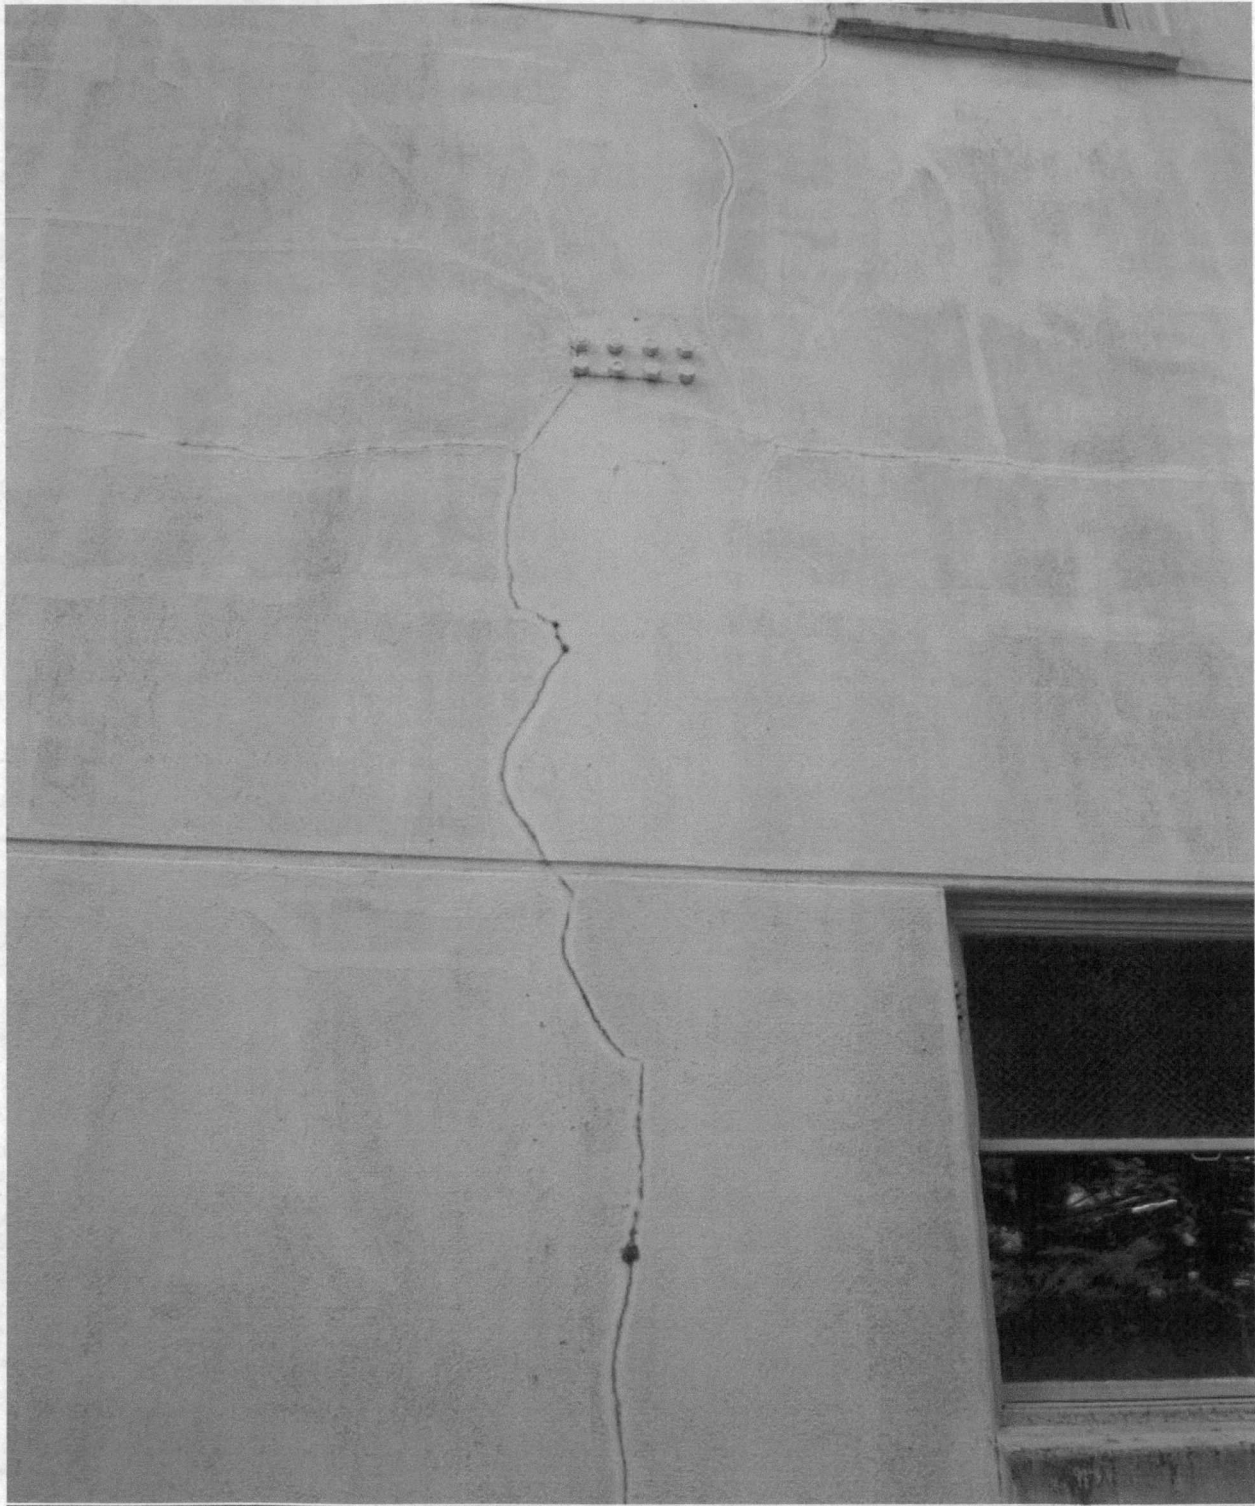
**Note** On above item, wall cracks on the exterior perimeter walls meet the size requirements listed to be compliant, but have an odd pattern on the north wall. This wall did not appear to have any construction joints to allow for shrinkage. This might account for random cracking that has occurred. See appendix photo #3

The existing condition of the both structures evaluated was good considering the potential age of the buildings. The only sign of structural distress noted was cracking on the exterior concrete walls. Cracks in walls are common and could be due to many different reasons. The wall cracks noted were tight and did not appear to be detrimental to the function of the structure. Based on existing condition of the structure we feel that the floor and roof system of the communications building were likely designed to support heavy loads.

3. Wall cracking on north wall

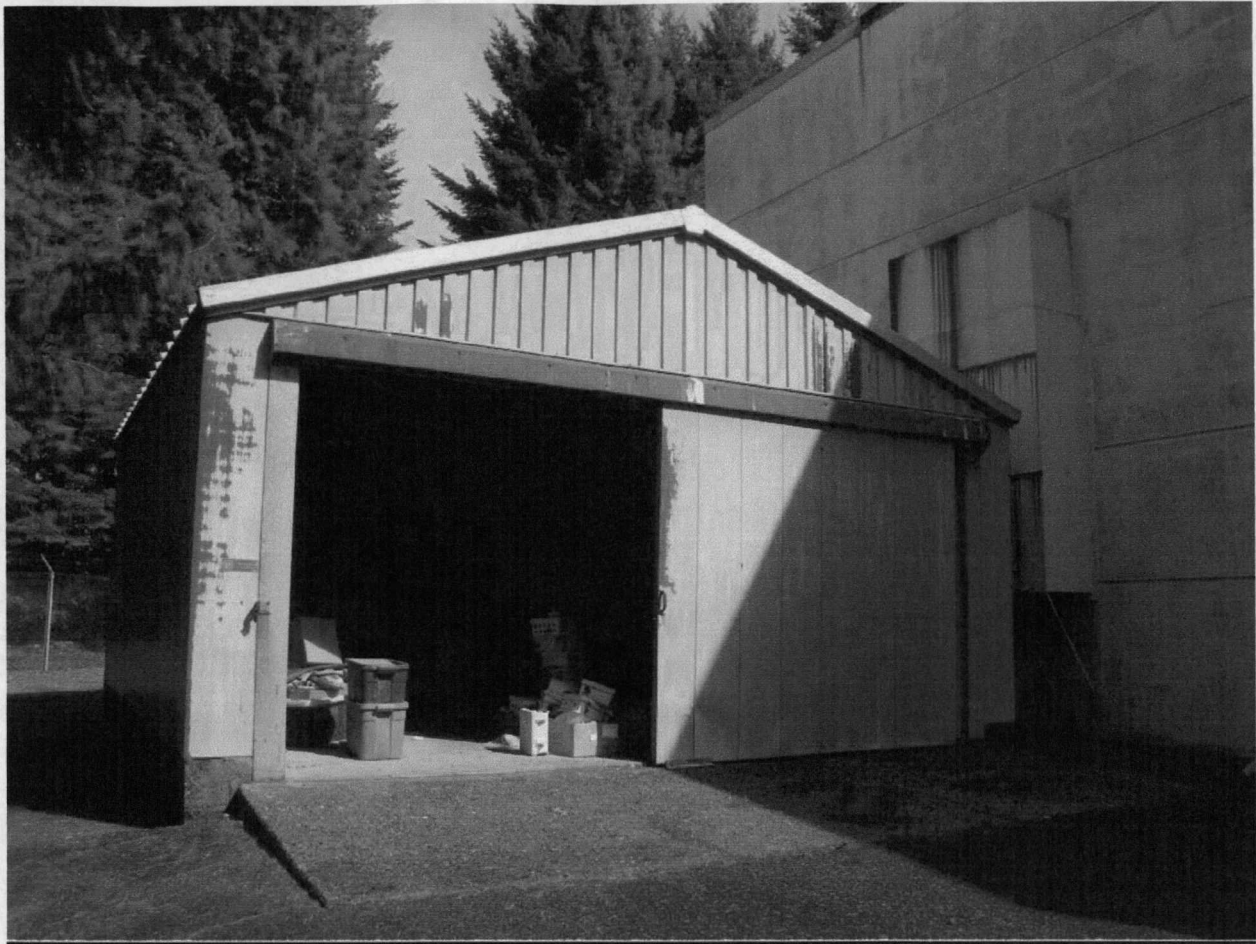
4. Accessory Garage Structure

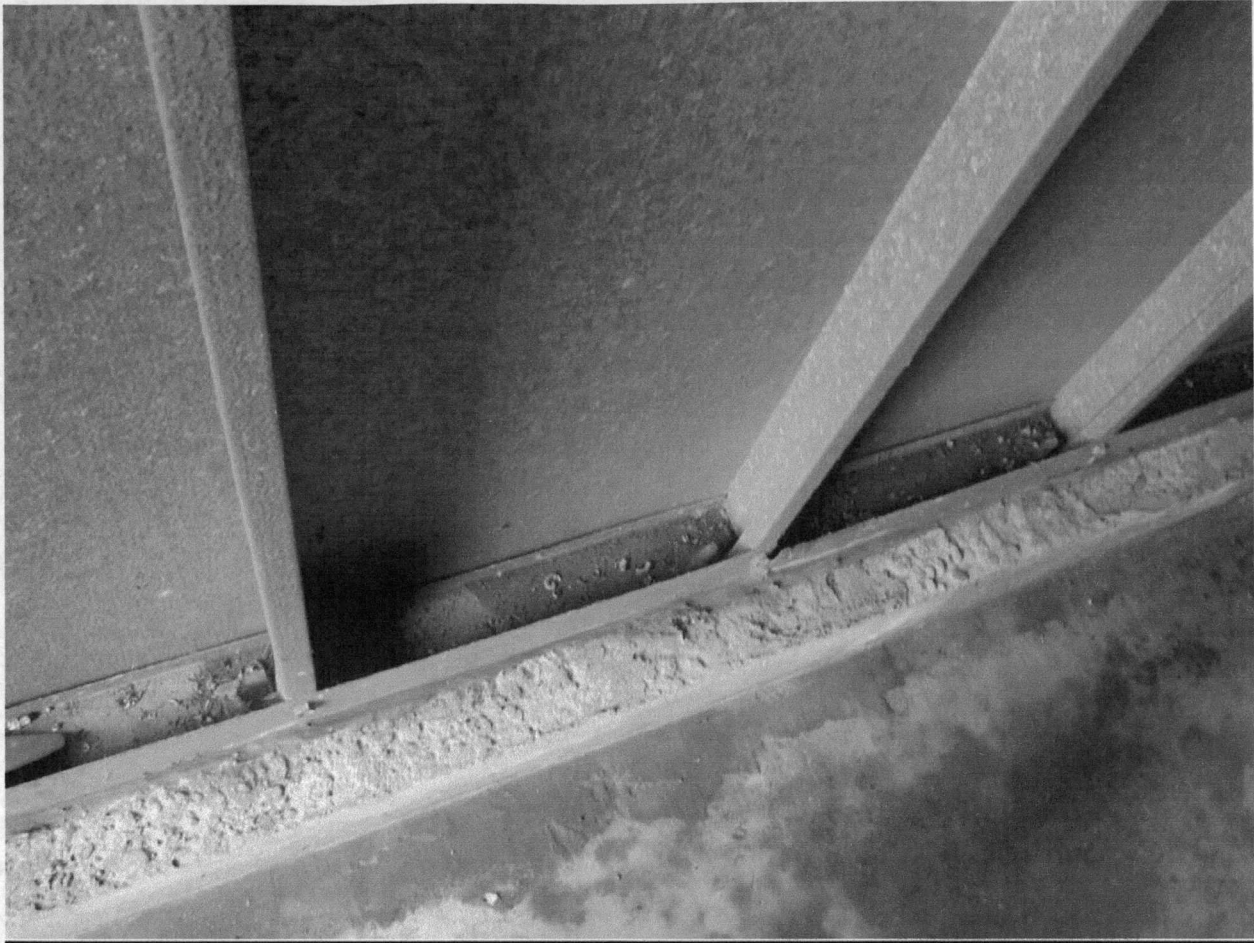
The primary lateral force (earthquake and wind) resisting system consists the steel panels described above attached to the concrete floor with ¼" anchor bolts at 16" on center. Lateral loads are transferred to the walls by flat strap x-bracing at the ceiling plane.

5. Accessory Garage Wall Panels and Sill Anchors

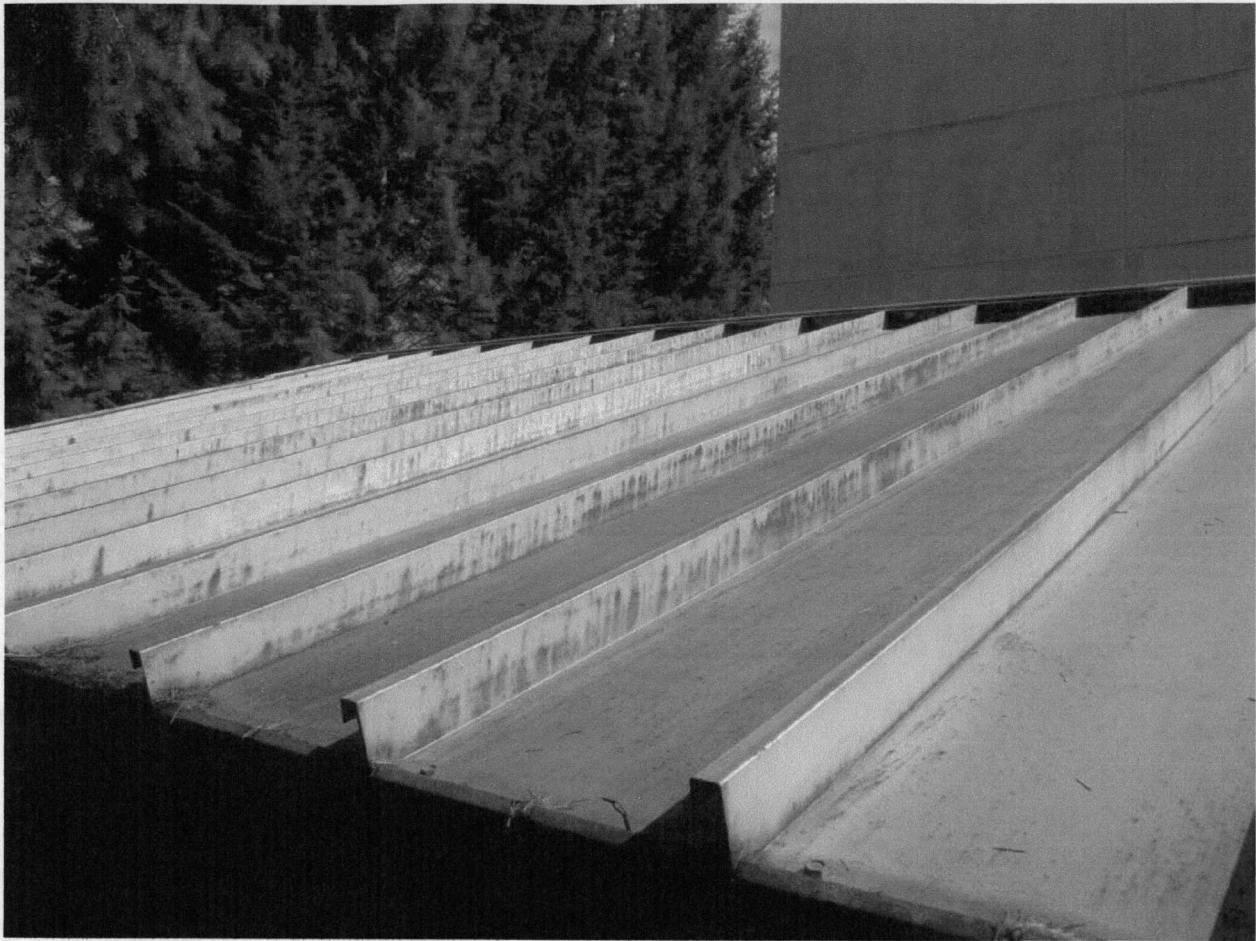
For gravity loading we are unable to calculate the capacities of the existing steel wall and roof panels due to the unknown thickness of the steel. Except for some corrosion starting to take place on the outer surface, the roof and wall panels are in good condition. We do not see any signs of overstress from past snow loading and don't feel this structure is deficient to support current gravity loads.

6. Accessory Garage Structure Roof Panel Condition
