Structural Evaluation Report  
for Existing Buildings at  
Livingston Mountain Communications Site  
Camas, Washington

American Tower  
Corporation

April 21, 2014

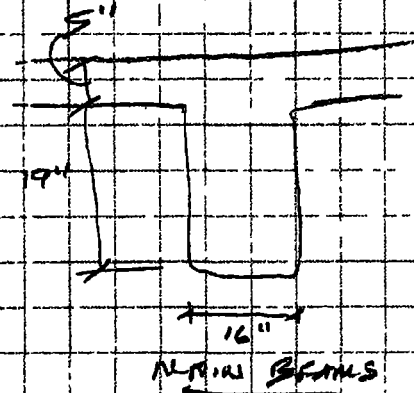
MINIMUM STEEL WOULD NOT BE ENOUGH TO CARRY DEAD LOADS OF THE STRUCTURE W/O SIGNIFICANT CRACKING.

SINCE NO CRACKING IS EVIDENT IN THE FIRST FLOOR SYSTEM, IT IS SAFE TO ASSUME ADEQUATE REINFORCEMENT EXISTS TO CARRY HEAVY EQUIPMENT LOADS THAT CURRENTLY EXIST ON THE SECOND FLOOR.

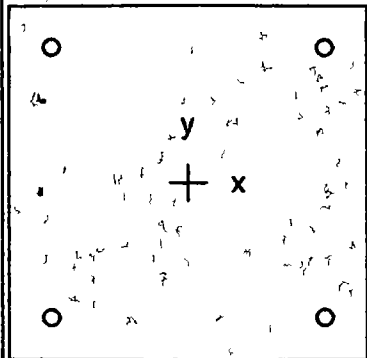
EVEN MINIMALLY REINFORCED COLUMNS APPEAR TO BE

ADEQUATE FOR ASSURED LOADING.
